Silicon identification

This errata sheet applies to the revisions 'A', 'Z', '1', '2' and 'Y' of STMicroelectronics STM32F405xx/STM32F407xx and STM32F415xx/STM32F417xx microcontroller families. In this document, they will be referred to as STM32F40x and STM32F41x, respectively, unless otherwise specified.

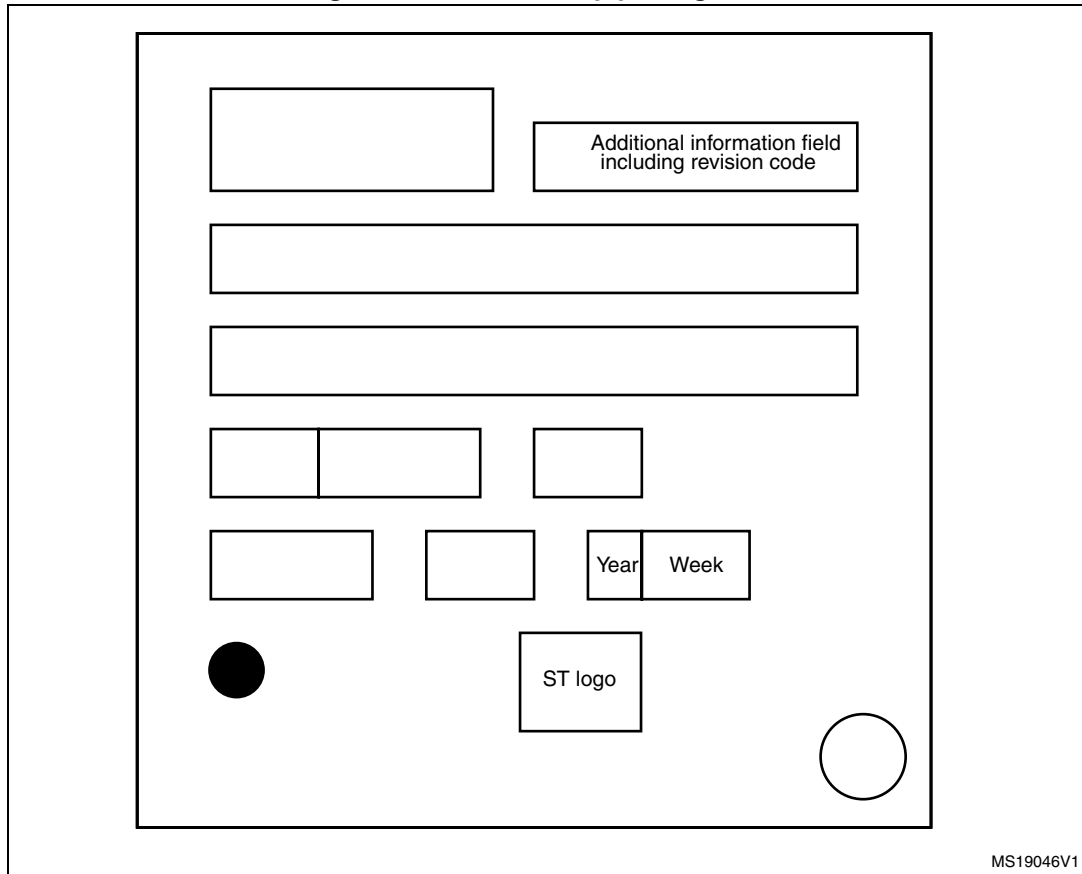
Figure 1. UFBGA176 top package view

Figure 1, Figure 2, Figure 3, Figure 4, Figure 5 and Figure 6 show the marking compositions for the UFBGA176, LQFP176, LQFP144, LQFP100, LQFP64 and WLCSP90 packages, respectively. The only fields shown are the Additional field containing the revision code and the Year and Week fields making up the date code.
